Water Quality Status Near Kalindi Vihar Colony, Tedi Bagiya, Agra, Uttar Pradesh, India.

-----Abstract-----

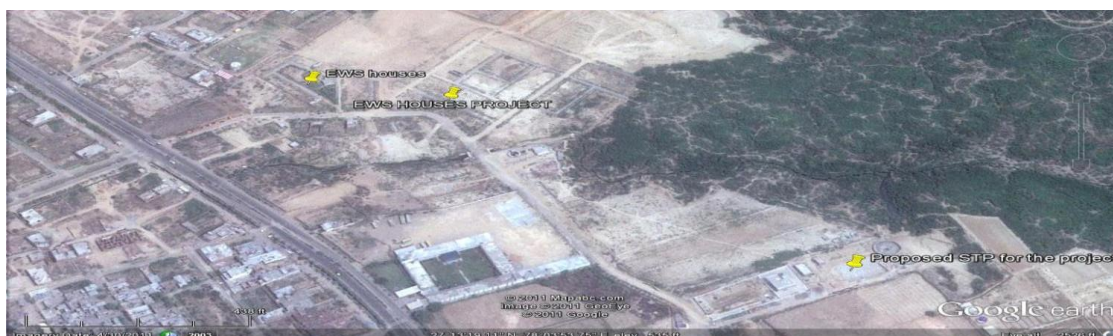
Figure 1.1 Aerial Photograph of Research Work Site.

1.2 Research Site: As mentioned above the site is located on the outskirts of the city. The geographical location of the work site is about 27°22'N, 78°08'E. The Site is located near NH 2 (towards Tundla) which connects Agra to Kanpur. From Aligarh it is about 80 km and it takes about 2 hrs to reach the site travelling on NH 93 which connects Agra to Aligarh. At proposed work site, EWS (Economically Weaker Section) Houses are to be constructed for economically backward section of society. This Project comes under the proposed Welfare Scheme of "Manyawar Shri Kanshiram Ji Shahri Garib Awas Yojna" undertaken by the erstwhile Government of Uttar Pradesh led By Shrimati Mayawati Ji. The work is being handled by U.P. Housing & Development Board under the supervision of Agra Development Authority. The site is an extension of Kalindi Vihar Yojana of Agra Development Authority, under Sector – H. Under the proposed work, 337 houses are to be built.

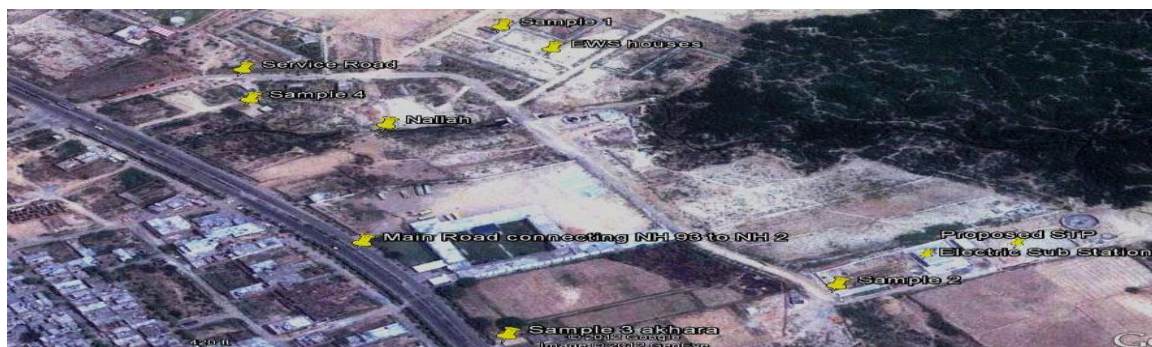
1. Near the under construction area of EWS houses
2. Near the Electric Sub station
3. From akhara situated near the main road connecting NH 93 to NH 2
4. At the midpoint of service road and Nallah.

Figure 3.1 Aerial Photograph showing the Location of Sampling Points

At all the sampling point's source was ground water and mode of water was bore – well.

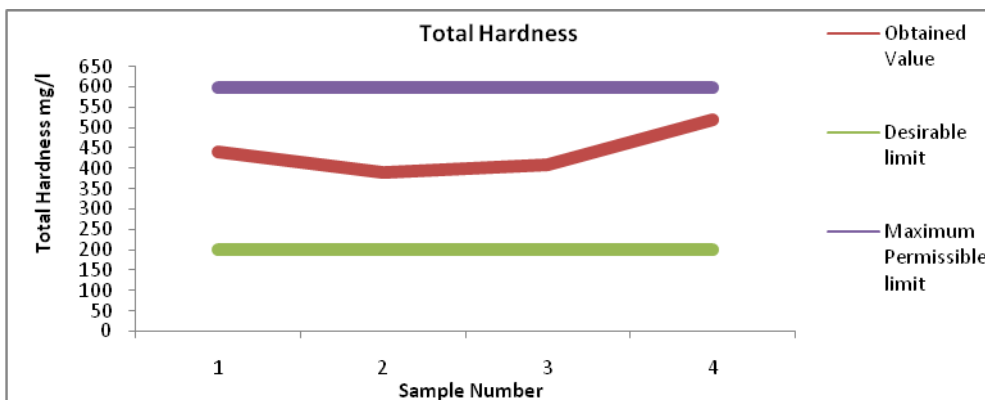
Figure 5.2 Graph between Sample's (Sample Number) v/s Total Hardness (mg/l)

This graph shows that values obtained for all the samples were within maximum permissible limits, but the values are high and the water is very hard.

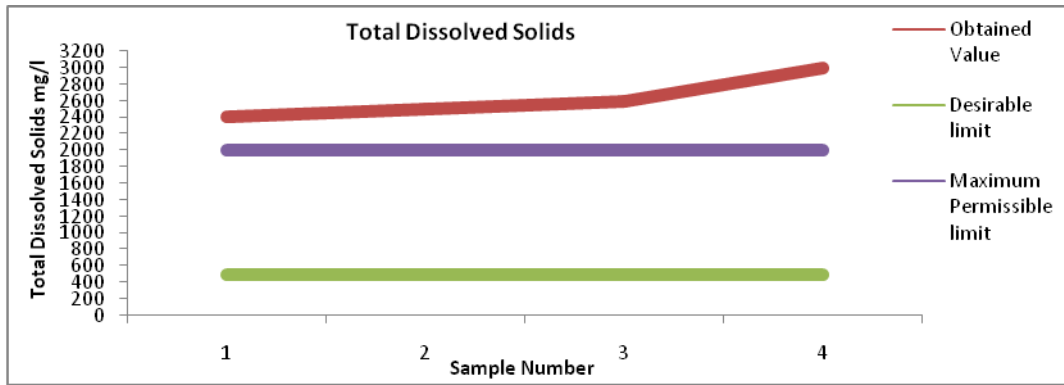
Figure 5.3 Graph between Sample's (Sample Number) v/s Total Dissolved Solids (mg/l)

This graph shows that values obtained for all the samples were well above maximum permissible limits, this shows that water is polluted there and it needs to be treated.
