## Yanamadurru Drain Water Quality Assessment during 12-13 March, 2016

T.Vidya Sagar, M. Bujji babu

Joint Chief Environmental Scientist, Andhra Pradesh Pollution Control Board, Board Office ,Hyderabad  
Analyst Gr-I, Andhra Pradesh Pollution Control Board, Zonal Office, Visakhapatnam

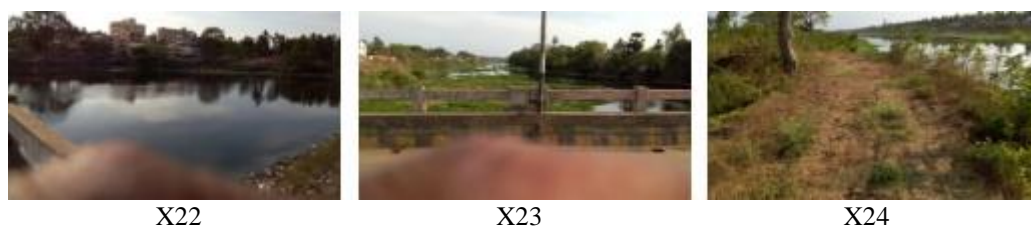
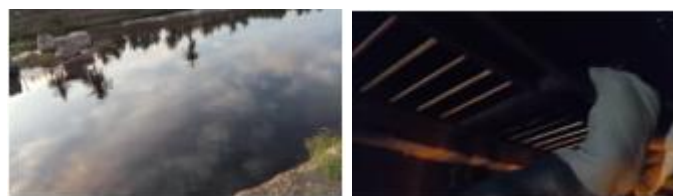
Fig. 3: Photographic views of Yanamadurru drain stretch from Prakasam chowk, Bhimavaram to Upputeru, Naidupalem.

Later, the team continued survey on bank of Yanamadurru drain downstream from Bhimavaram Town. Sample is collected near Prakasam chowk (S14, X22), then reached to Government hospital road and collected sample near footpath bridge connecting 1 and 2 towns of Bhimavaram (S15, X23). It reached Bhimavaram lakulu connecting Kalipatnam canal (agriculture) and collected sample from Yanamadurru drain (S16, X24). Then it reached Yanamadurru village and collected sample from Yanamadurru drain (S17, X25). It finally proceeds to Naidupalem before confluence point of Upputeru and collected samples from the Yanamadurru drain (S18, X26). Photographic views of Yanamadurru drain stretch from Prakasam chowk, Bhimavaram to Upputeru, Naidupalem are covered in X22-26 at Fig. 3. The samples details referred as S1-18 are placed at column 2 and Photographs X1-26 are referred at column 1 TABLE 1.

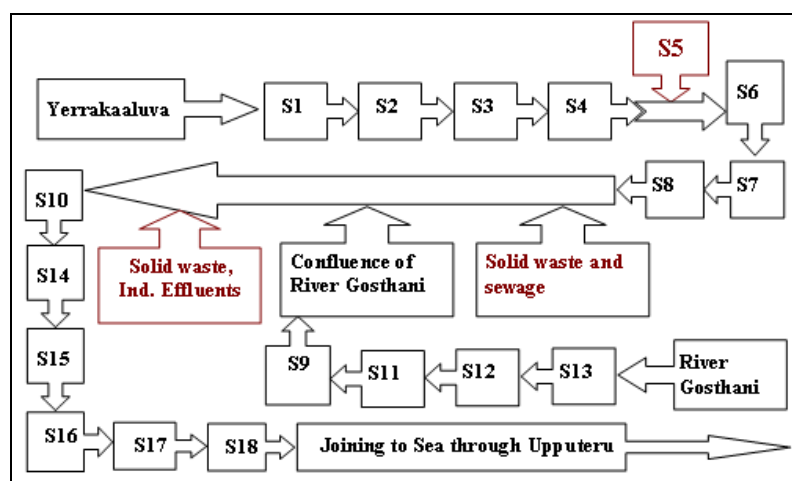
Figure 4: S1–7 (Gr.1), S5 inlet pipe, S8, S10, S14–18 (Gr.2), S9, S11–13 (Gr.3).

The sampling points are sequenced from upstream to downstream and shown diagrammatically at Fig.4 with representation as S1–18 along the Yanamadurru drain and River Gosthani stretches grouped as S1–7 (Gr.1), S5 inlet pipe, S8, S10, S14–18 (Gr.2), S9, S11–13 (Gr.3).
