## Use of Non-Destructive Tests (NDT) To Assess the Concrete Strength of a Concrete Structure: A Case Study

The quality of concrete can be judged by its compressive strength. Non-Destructive Tests (NDT) are necessary to assess the compressive strength of structural members in an existing building like the one under study (Emmanuel Egboga building, University of Ibadan, Oyo State, Nigeria). The purpose of this research work is to investigate the strength of this building which has shown cracks of different nature, to ascertain the safety of the building.

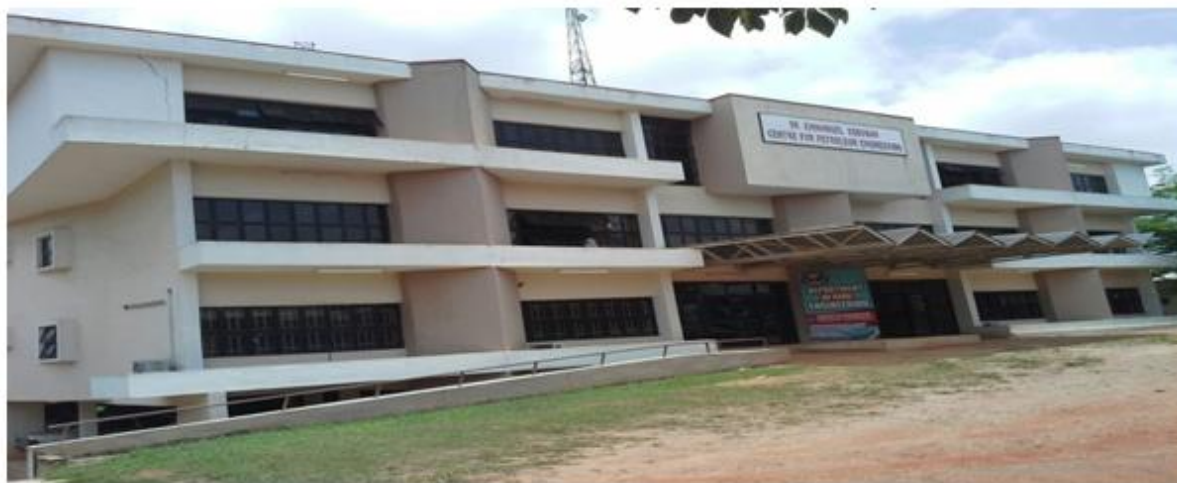
**Plate 1: Front View of Egboga Building**

Emmanuel Egboga building has 53 rooms, and four floors, which are basement floor, ground floor, first floor, and second floor as shown in Figure 2. The structural frame members consist of 129 beams, 92 columns, and 240 walls in total. It is covered at the roof with aluminium roofing sheets, and contains roof gutter for proper drainage. It also contains retaining wall that links the basement floor to the ground floor.

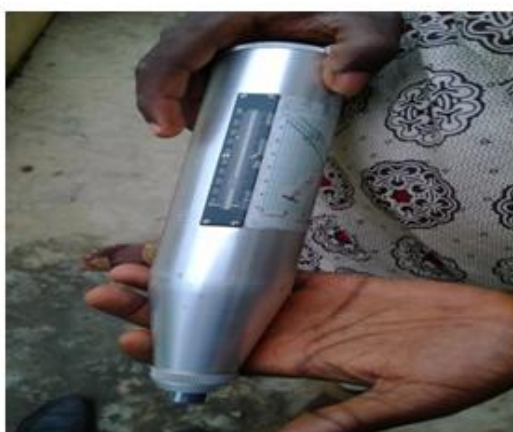
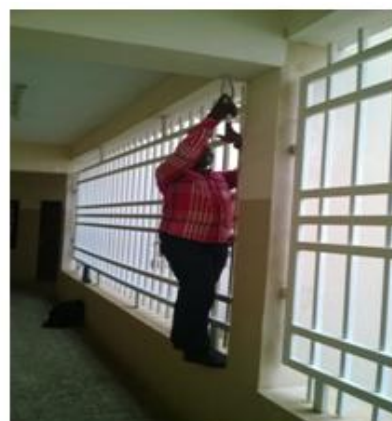
A Schmidt hammer was used to assess the strength of the structural elements (See Plates 2 and 3 respectively). The strength of each structural member was obtained by taking the average of seven recorded values of Schmidt Hammer Reading. The Non-Destructive Schmidt Hammer Test conducted on the building under appraisal comprises of the basement, ground, first, and second floor. The summary findings were presented in Table 4.

**Plate 2: Picture Showing the Schmidt Hammer and Schmidt Hammer Reading of Beam**

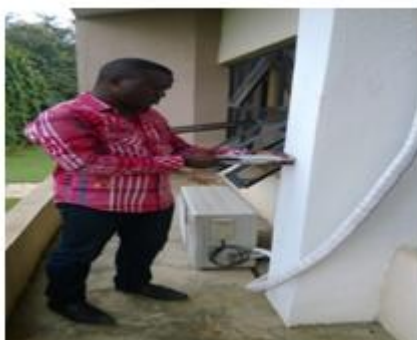
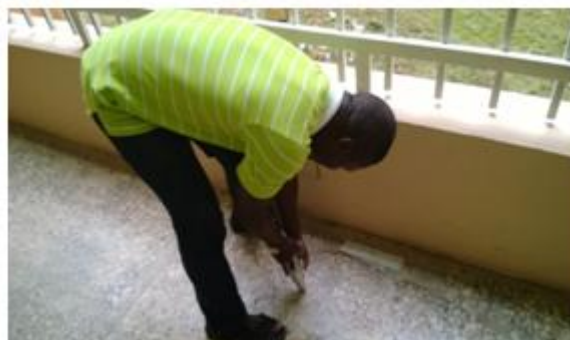
**Plate 3: Picture showing Schmidt Hammer Reading of Column and Floor Slab**
